# **Behavior of Stainless Steel in Marine Atmosphere**

Mekonen Bayssie and Geoff Hornseth  
SNF Storage & Transportation Division, US Nuclear Regulatory  
Commission

Intl Seminar on Spent Fuel Storage (ISSF  
2010)

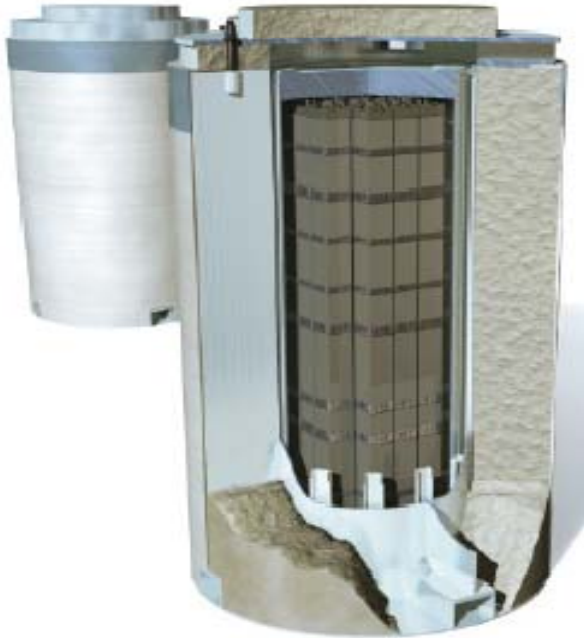
NRC NUREG-1350

- Nuclear power plants have turned to dry cask storage facilities
  - Most dry storage casks are made of austenitic stainless steel (304, 304L, and 316L)
  - Most systems use a stainless steel cask inside a concrete bunker or steel in a concrete cask with passive ventilation

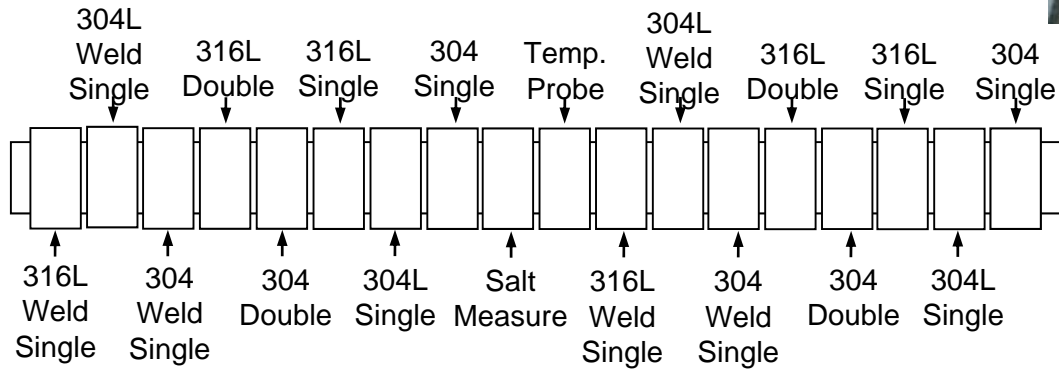
Schematic of the U-bend specimen arrangement on each cartridge heater

- Single and double U-bend specimens mounted on cartridge heaters
- 304, 304L, and 316L
- Gas tungsten arc welded U-bends
- 304/308, 304L/308L, and 316L/316L
- Rolling direction was perpendicular to length

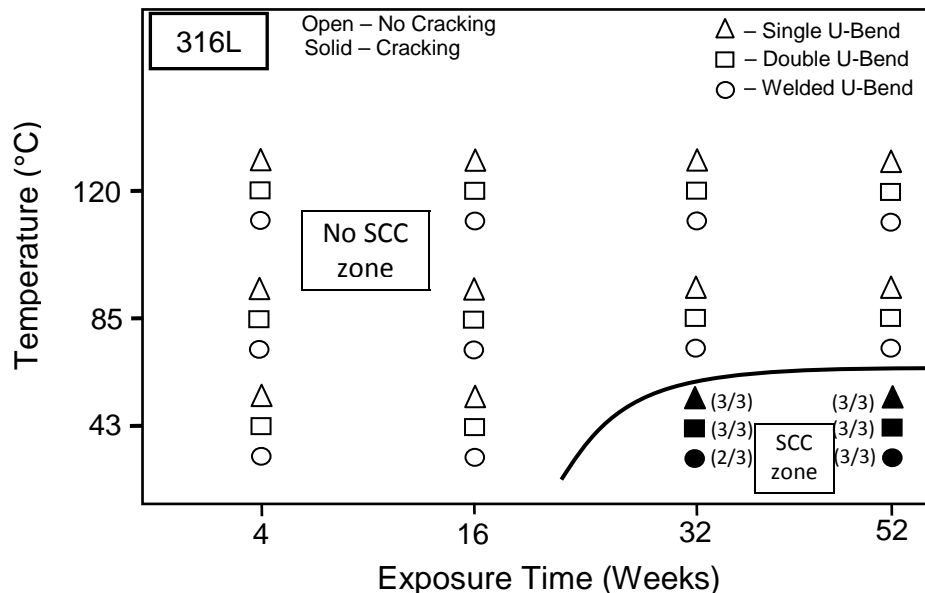
SCC susceptibility map (number in parenthesis states number of specimens cracked/total number of specimens tested)

- Cracking was only observed in all the 43 ° C [109 ° F] samples
- Cracks had mixed transgranular/intergranular morphology
- Cracks concentrated within the arch region in all unwelded U-bends and at the heat-affected zone of the welded specimens
- Cracks initiated 32 weeks after exposure
- Cracking severity increased with exposure time

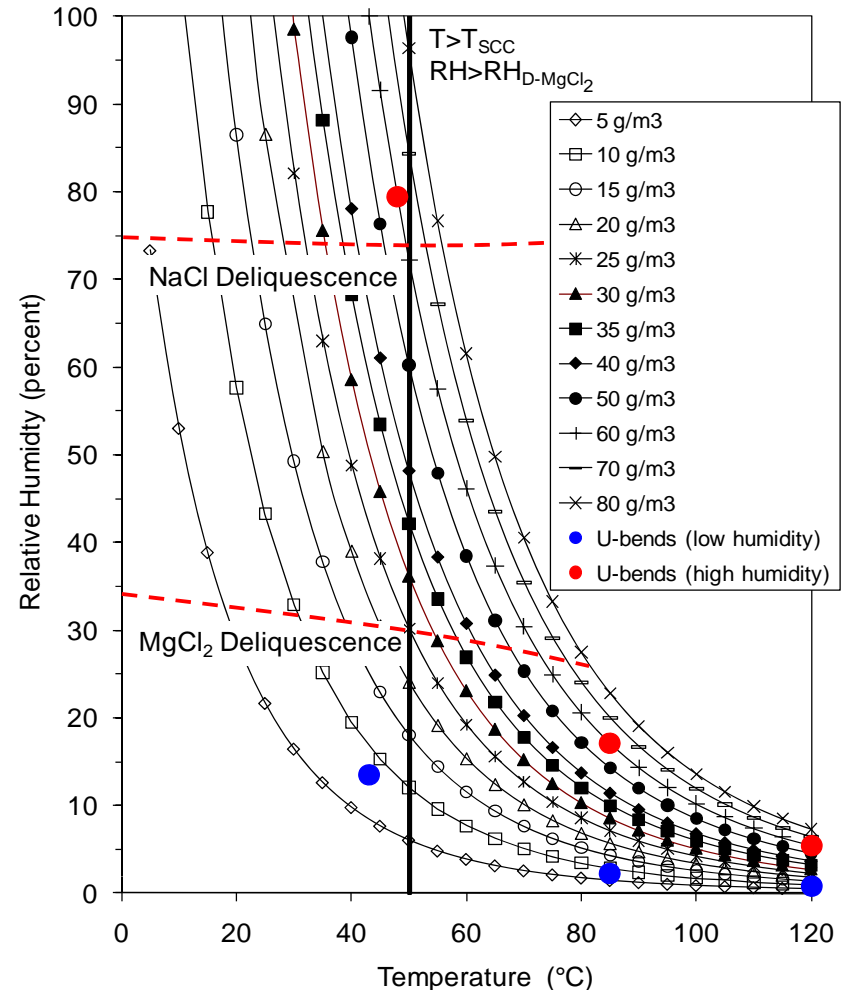
Evolution of the relative humidity versus temperature for various absolute humidity. The region between the red (maximum humidity) and blue (minimum humidity) circles indicate the expected environmental conditions near the U-bend surface in the salt fog test

- Typically, the maximum observed absolute humidity in natural environments is less than 30 g/m<sup>2</sup>
- Test used conservative absolute humidity of 60 g/m<sup>2</sup>
- High absolute humidity was sufficient to exceed the relative humidity necessary for the deliquescence of salts deposited on specimens maintained at 43 ° C

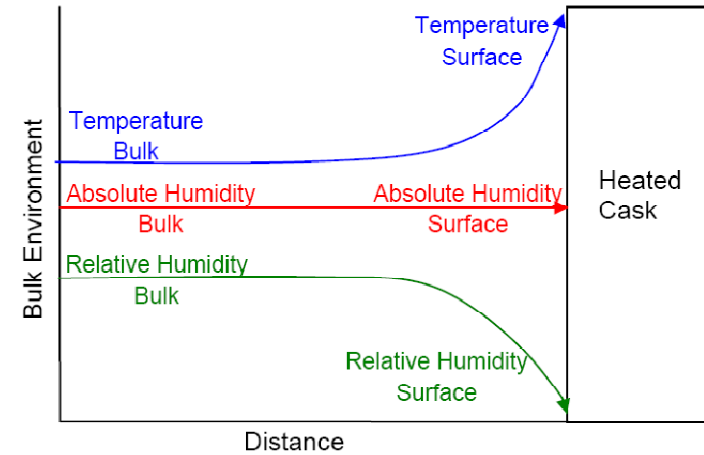
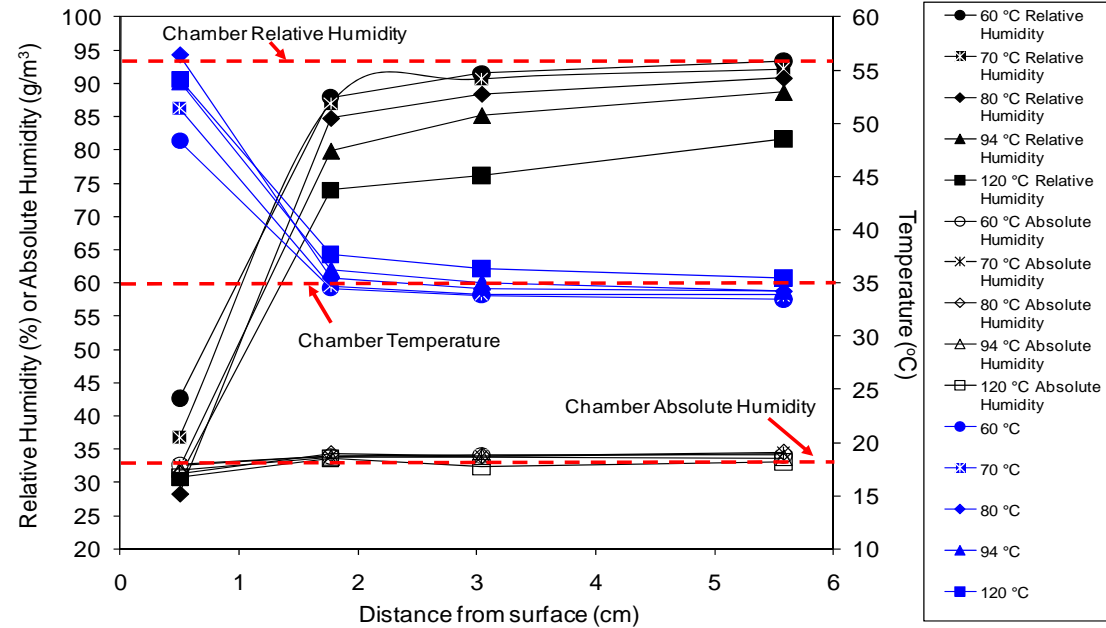
Temperature, absolute humidity, and relative humidity profiles versus distance from the U-bend samples heated at different temperatures

- Air temperature increases near the sample surface
- Absolute humidity remains similar to bulk environment
- Relative humidity decreases near the sample surface
