**Integrity Inspection of Dry Storage Casks  
and Spent Fuels at Fukushima Daiichi  
Nuclear Power Station**

**16 November 2010**

**Tokyo Electric Power Company**

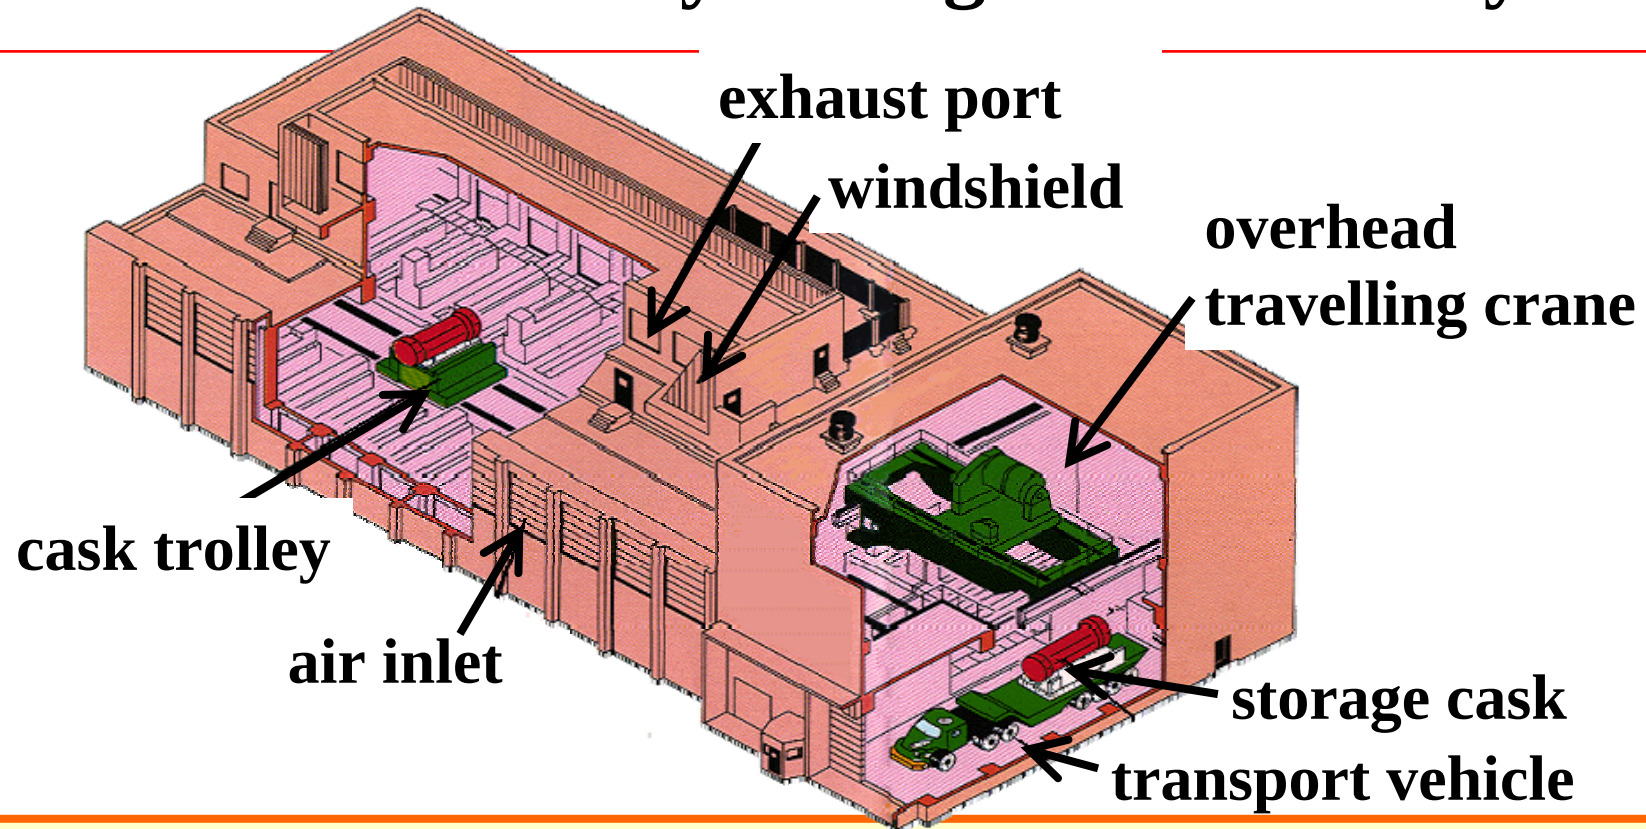
# Outline of Dry Storage Cask Facility

- ◆ Originally designed for transport casks  
→ Modified the license in 1994 / dry cask storage since 1995
- ◆ Permission for the storage of 20 casks  
- 9 dry casks are in operation, 11 casks are to be installed.
- ◆ Efficient use of existing building → Casks are laid down in horizontal
- ◆ Natural-convection cooling

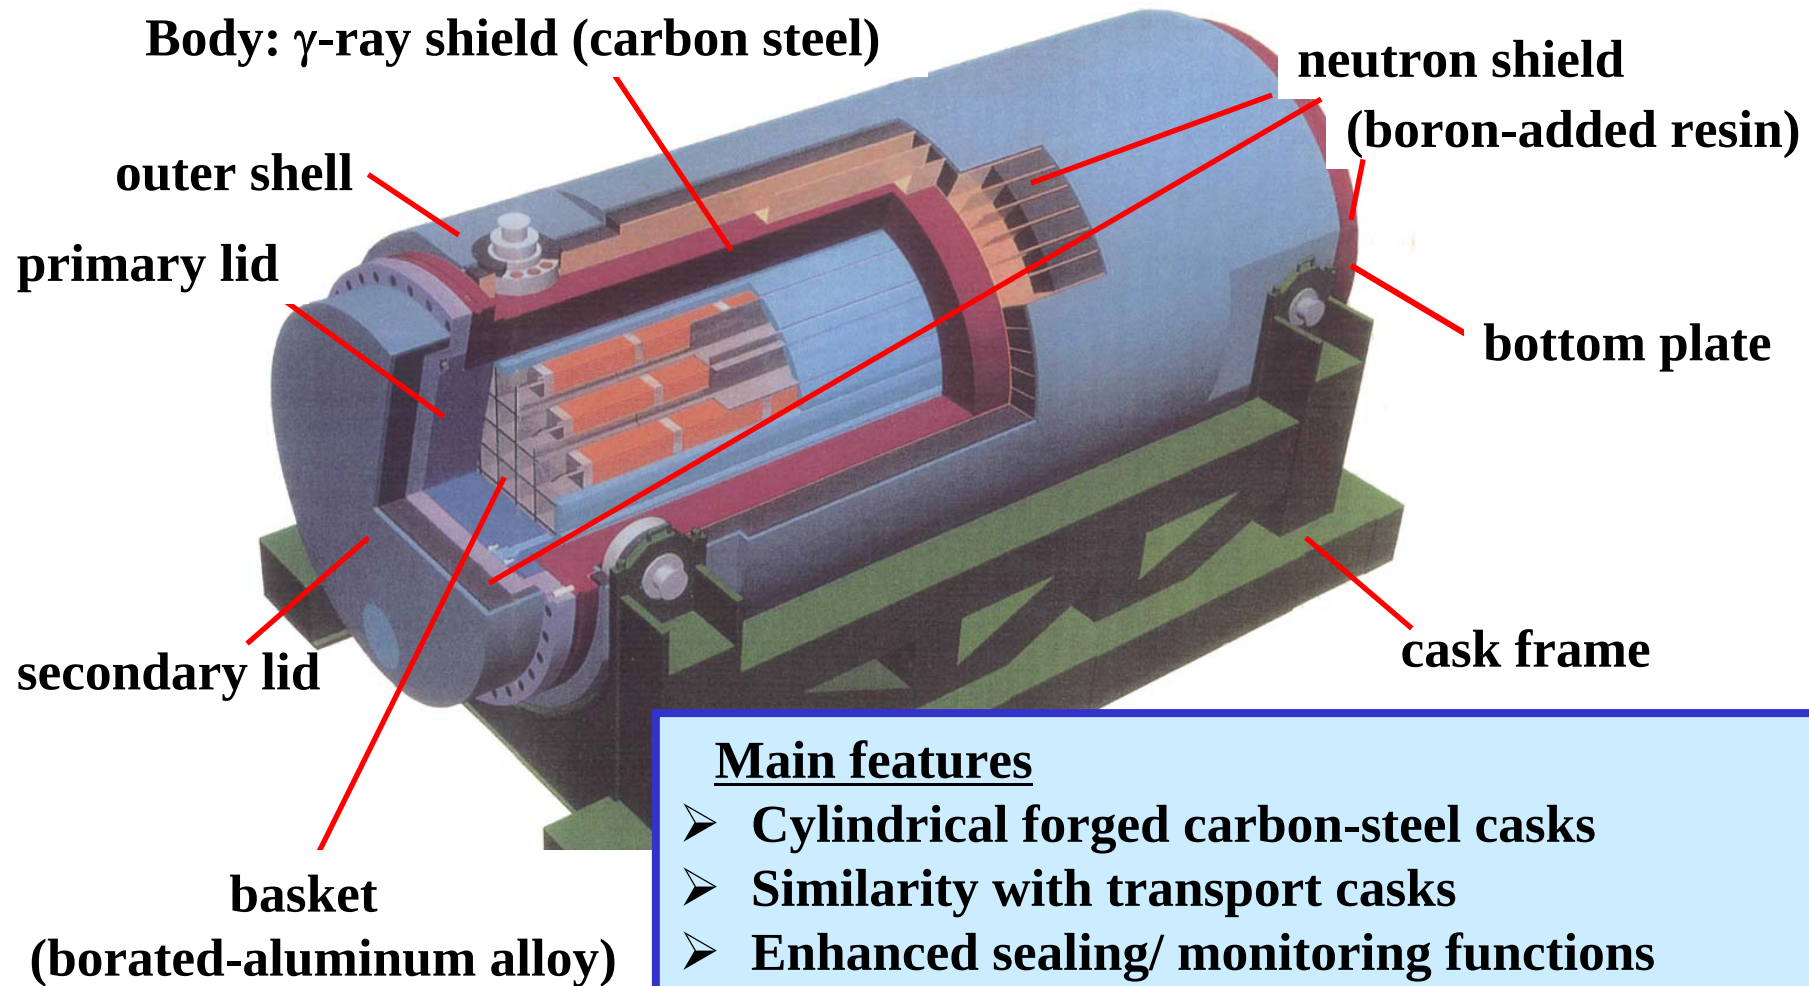
# Structure of Dry Cask

- Cylindrical forged carbon-steel casks
- Similarity with transport casks
- Enhanced sealing/ monitoring functions
- Inner gas substituted with helium
- Steel for  $\gamma$ -ray shield/ resin for neutron shield
- Borated-aluminum alloy basket for sub-criticality

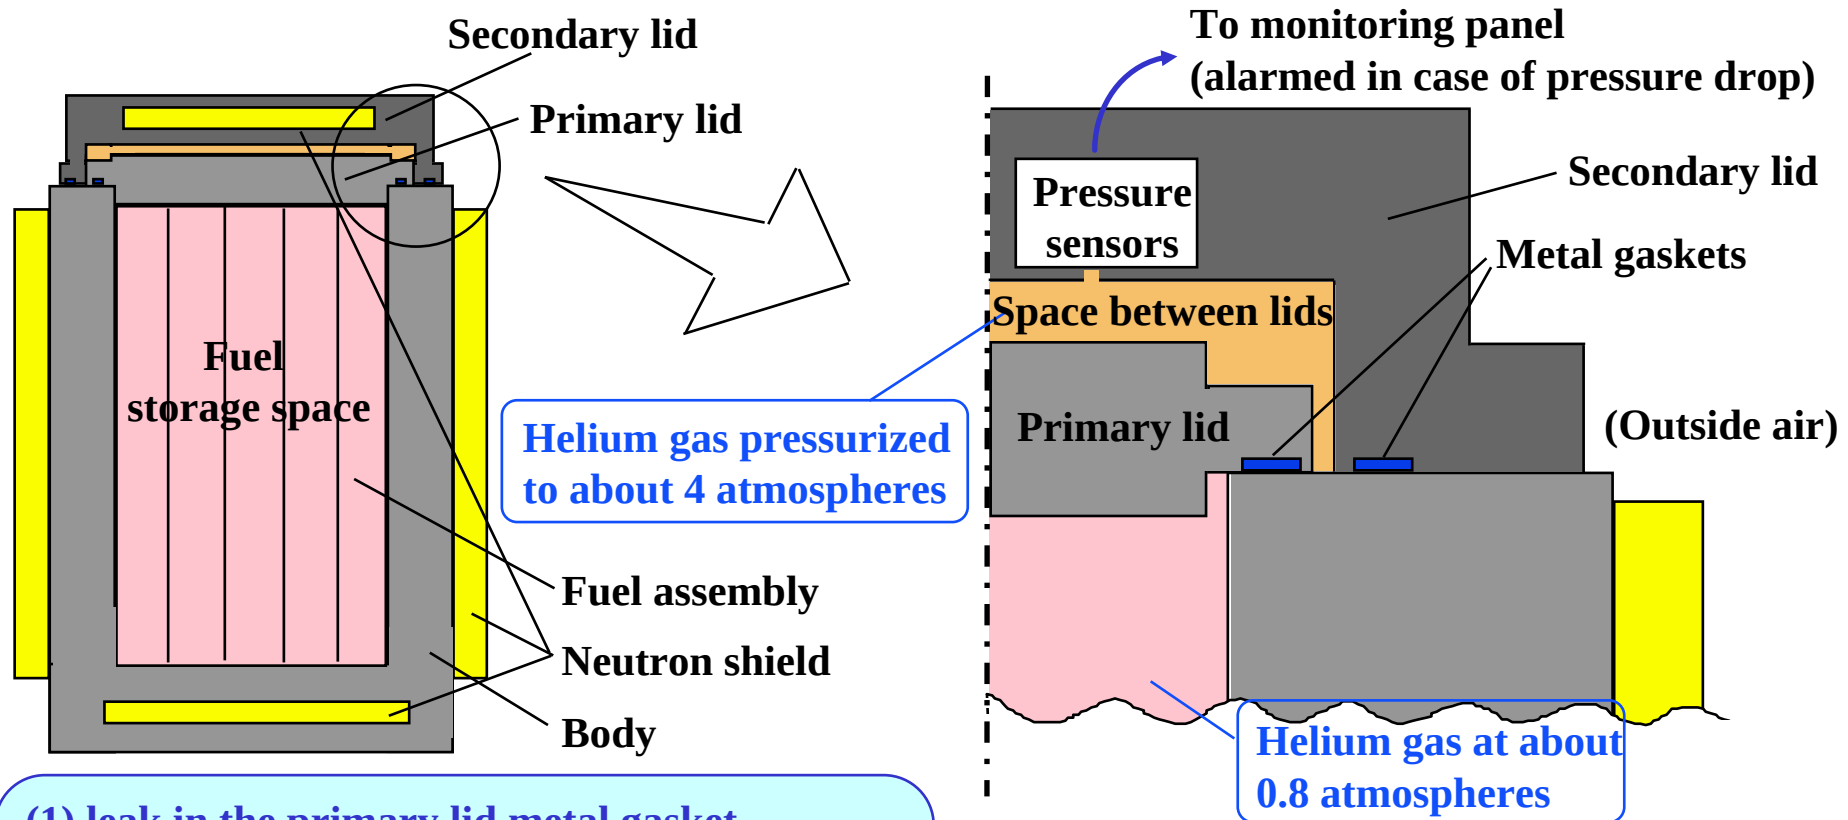
# Design Features Concerning Containment

(1) leak in the primary lid metal gasket

Space between lids → Helium gas → Fuel storage space

(2) leak in the secondary lid metal gasket

Space between lids → Helium gas → Outside air

Alarmed in case of pressure drop

Even if a leak in a metal gasket occurs, no radioactive material inside the cask (in the spent fuel storage space) is released outside the cask.

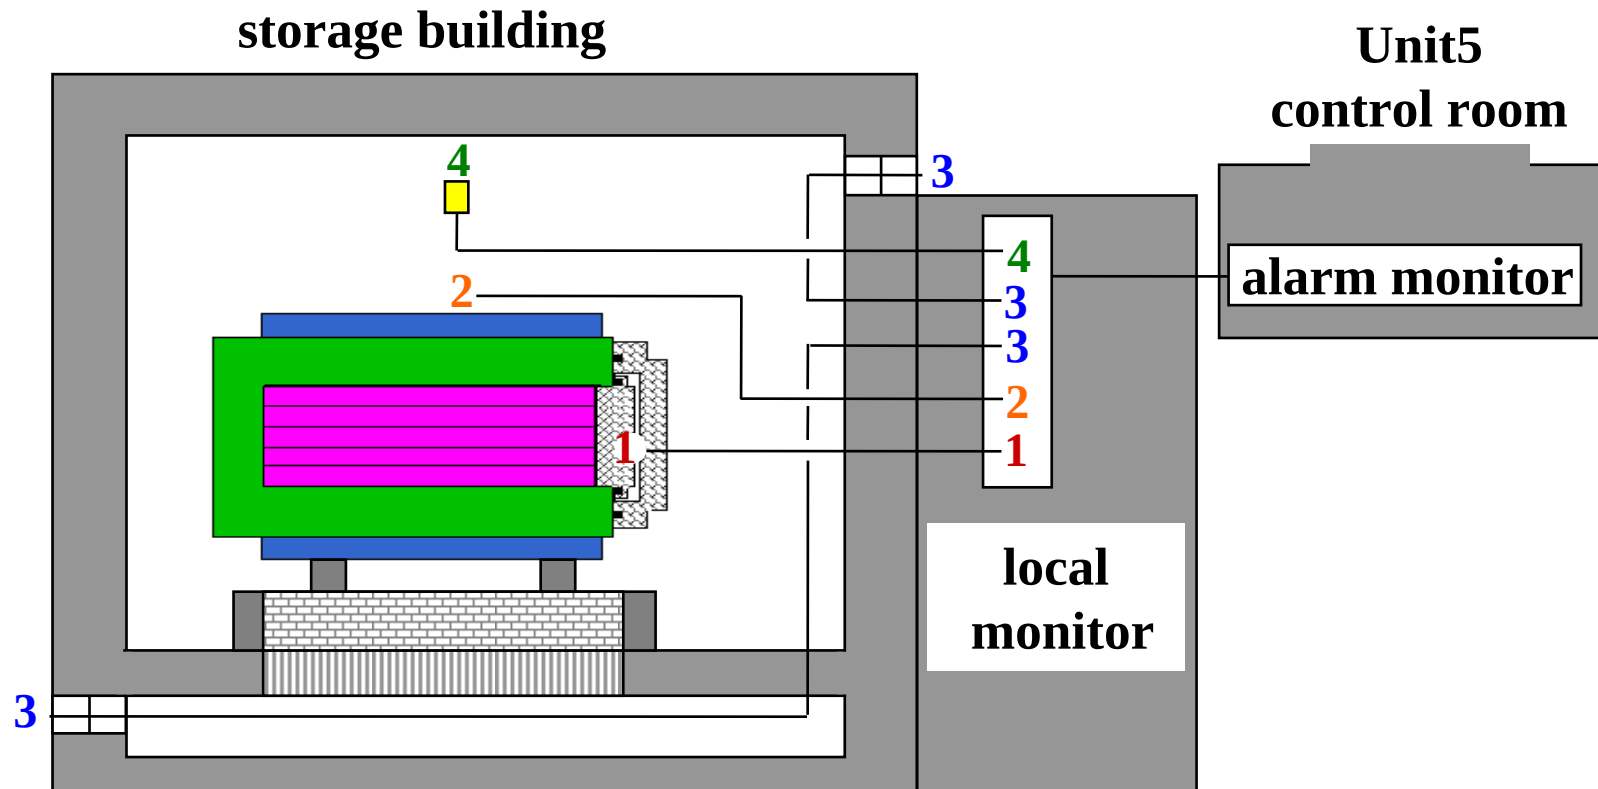
# Monitoring System at Normal Conditions

1. pressure between primary /secondary lids
2. surface temperature
3. inlet and outlet air temperature / temperature difference
4. area radiation in the building

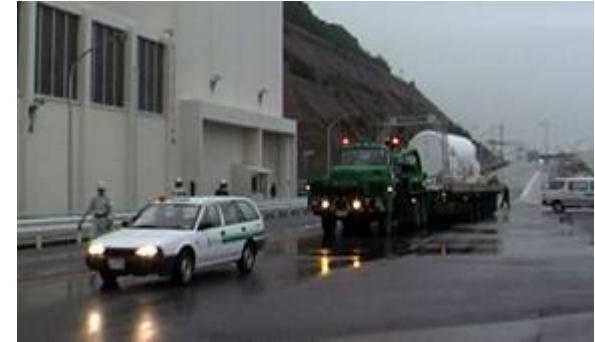
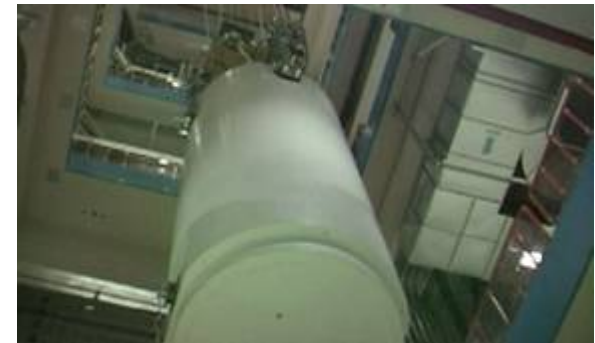
# Procedure of the Inspections

- 1) Transportation of a cask from the cask storage building to a reactor building
- 2) **Leak test of the secondary lid**
- 3) Secondary lid opening / **visual inspection**
- 4) **Leak test of the primary lid**
- 5) **Inner gas sampling for Kr-85 detection**
- 6) Reflood / removal of bolts
- 7) Transportation into fuel pool
- 8) Primary lid opening / **visual inspection**
- 9) Lift up of a fuel bundle / **visual inspection**

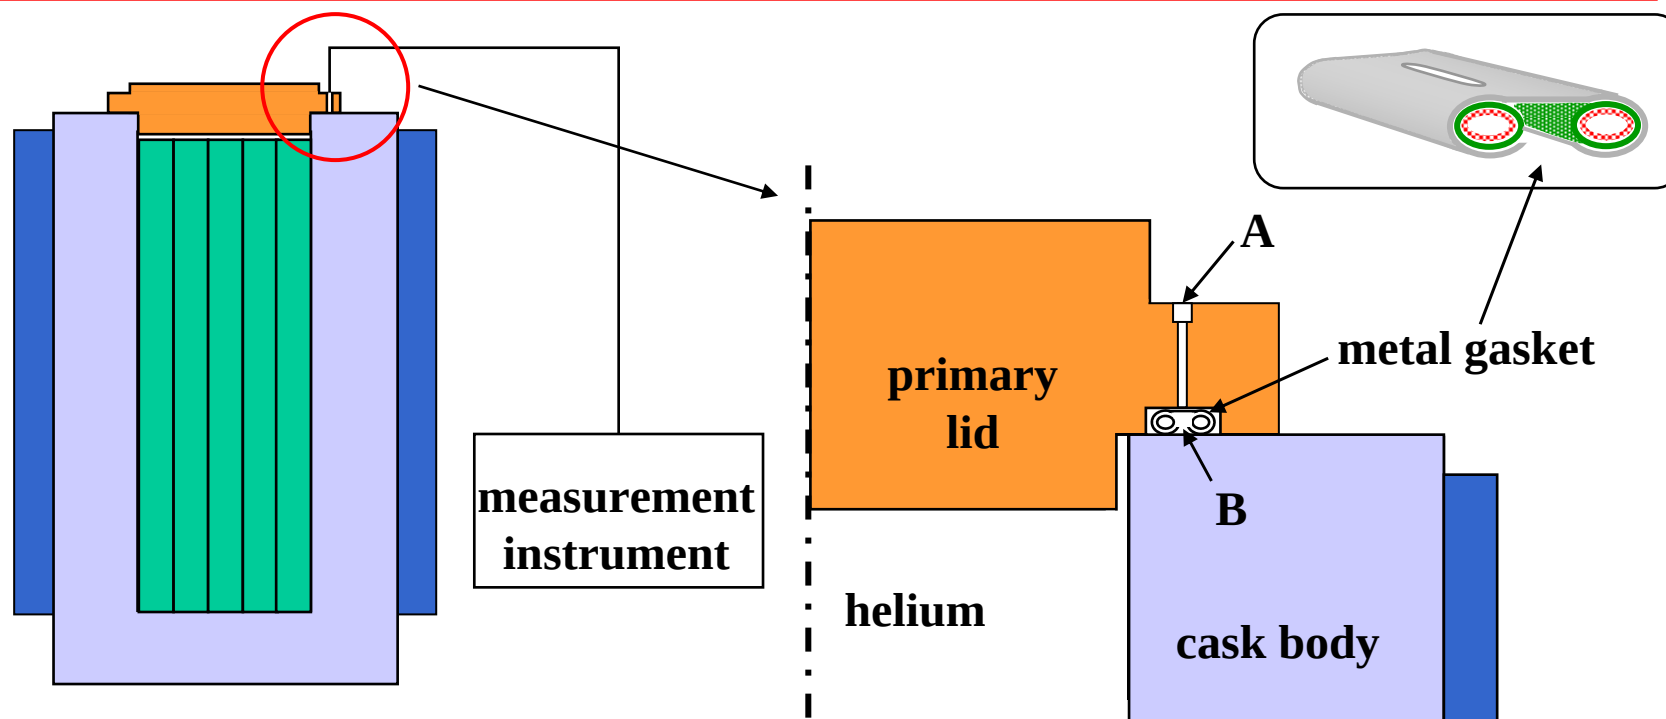
# Leak Test for a Primary Lid

1. A flexible pipe is connected to a detection hole (A).
2. The other end of the pipe is connected to the measurement instrument.
3. Helium among the doubled layer of a metal gasket (B) is vacuumed by a vacuum pump which is installed in the measurement instrument.
4. Flow rate of helium gas passing through the metal gasket is measured.
5. The measured amount is converted into leak rate.

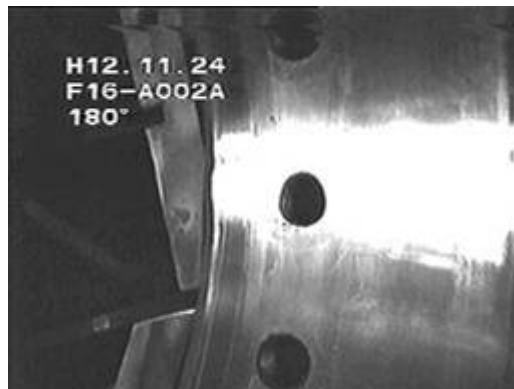
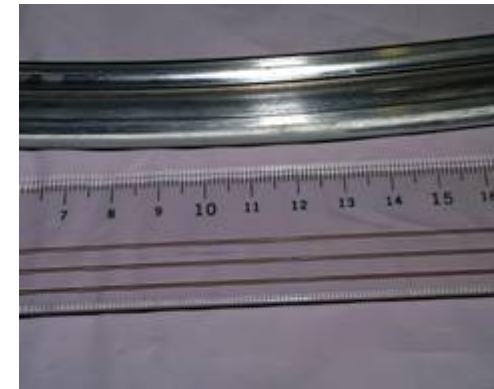
### ➤ Visual inspection of the primary lid

← Flange surface  
of the cask

Metal gasket  
of the primary lid →

⇒ **Nothing abnormal occurred on confinement, but white coloring was observed on the gasket's surface due to residual water.**

➤ All metal gaskets were replaced.

➤ Procedure manual was updated so that residual water could be completely removed.

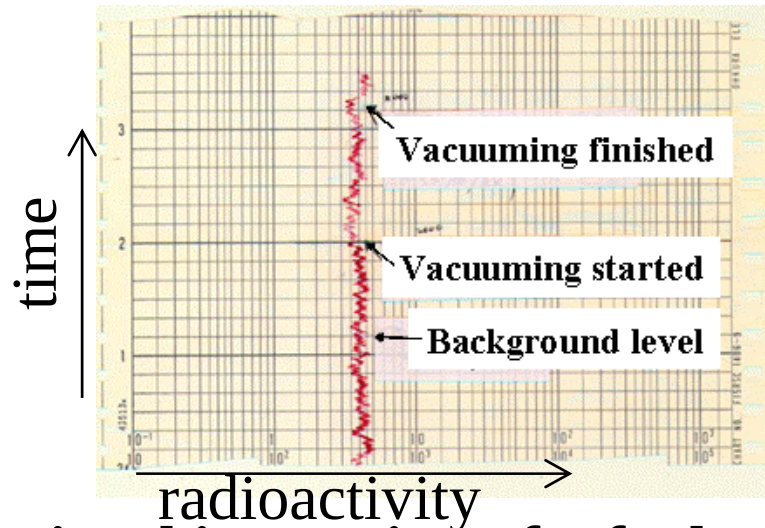
### ➤ Inner gas sampling for measuring Kr-85 concentration

⇒ No leak of Kr-85 from the spent fuel was observed based on the measurement of radioactivity of the sampled gas.

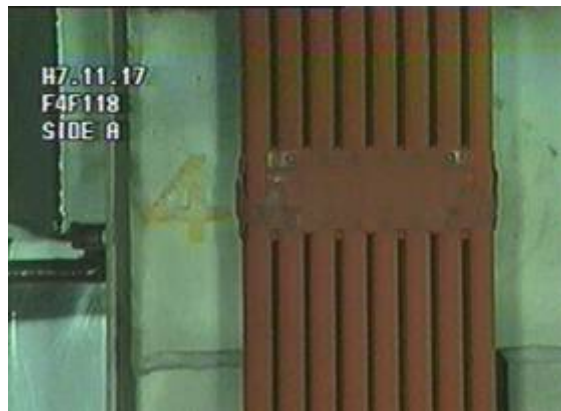
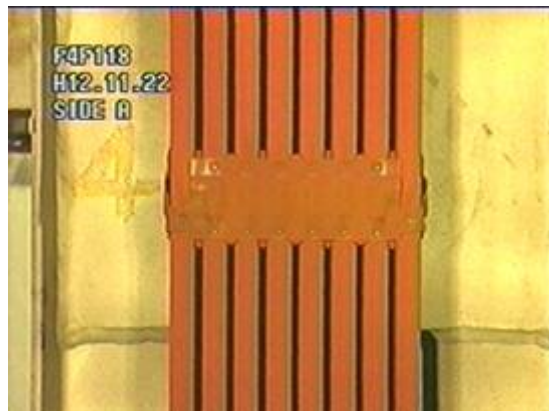
### ➤ Visual inspection of a fuel assembly

17/Nov/1995

22/Nov/2000

⇒ No signal of any defect was observed.

Target: New 8X8 BWR assembly (approx. 32 GWd/t)

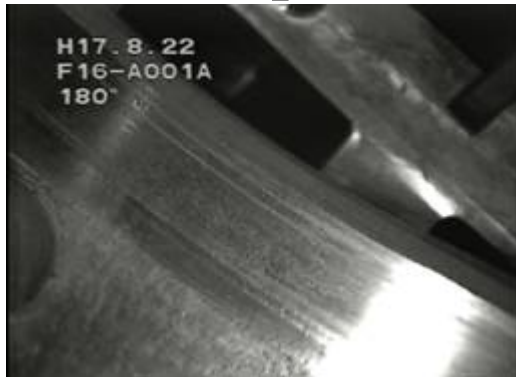
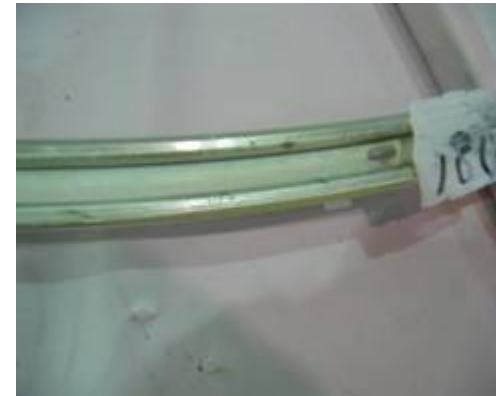
### ➤ Visual inspection of the primary lid

← Flange surface  
of the cask

Metal gasket  
of the primary lid →

⇒ **Nothing abnormal occurred on confinement, but white color change was observed on the surface of the gasket due to immersion to reactor pool water for several days before opening the primary lid.**

➤ **Procedure manual will be additionally updated in order to reduce the immersion duration.**

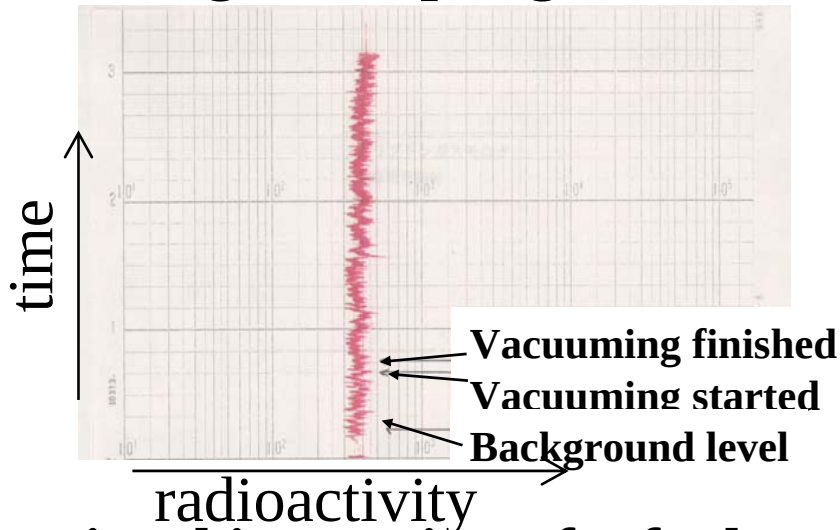
### ➤ Inner gas sampling for measuring Kr-85 concentration

⇒ No leak of Kr-85 from the spent fuel was observed based on the measurement of radioactivity of the sampled gas.

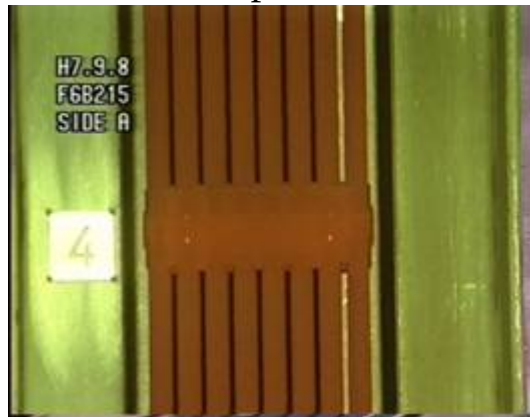
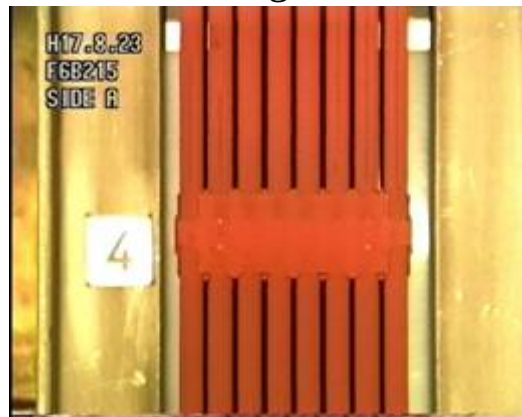
### ➤ Visual inspection of a fuel assembly

8/Sep/1995

23/Aug/2005

⇒ No signal of any defect was observed.

Target: 8X8 BWR assembly (approx. 28 GWd/t)
