INSPECTION OF FUEL CLADDING AND METAL GASKET IN METALLIC DRY CASK AT TOKAI No.2 POWER STATION

16 November 2010
Takeshi FUJIMOTO

THE JAPAN ATOMIC POWER COMPANY

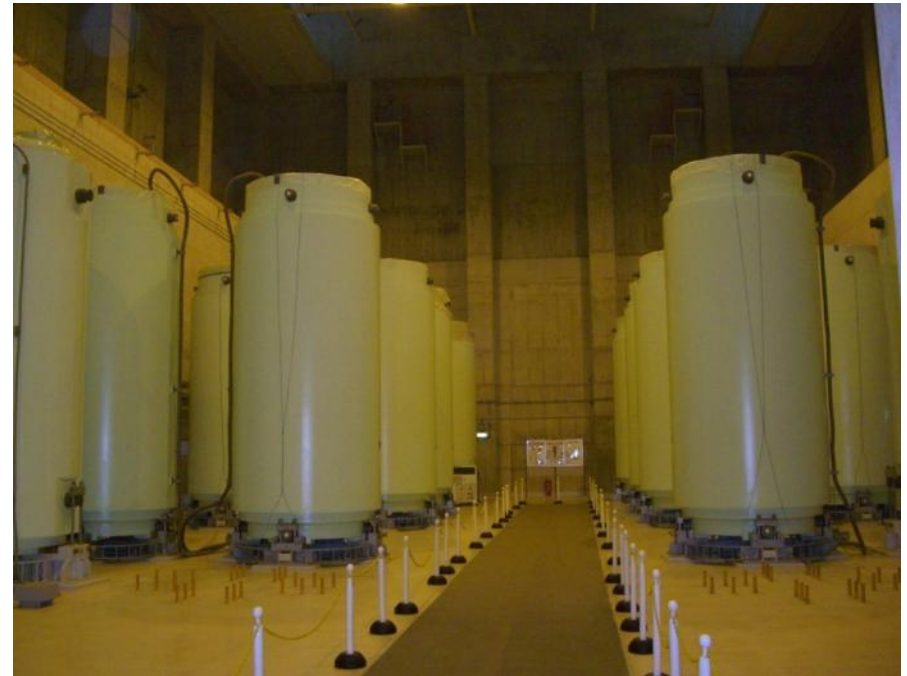
SPECIFICATIONS OF DRY CASK STORAGE FACILITY(1/2)

Cask number	24 casks can be stored. (There are 17 casks now.)
Cooling method	Natural Circulation
Storage state	Vertically Standing

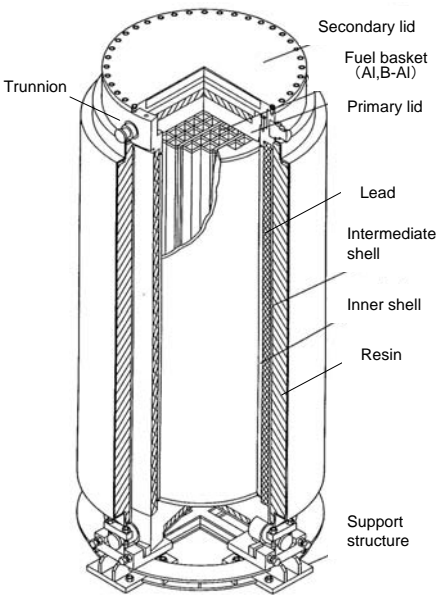
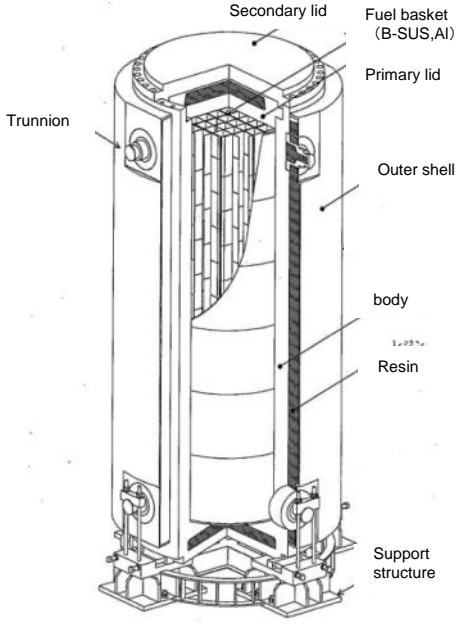
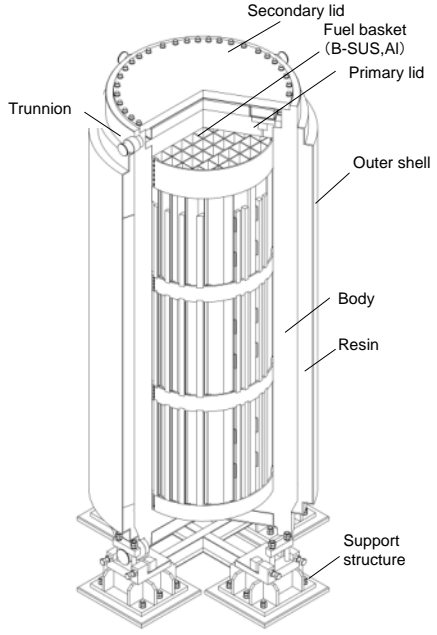
Cask	No.1~15	No.16~17	No.18~21
Cask type (Air view)

Manufacturer	Hitachi Zosen	Hitachi GE	Toshiba
Number of fuel	61		
Storage fuel type	8 × 8, new8 × 8, new8 × 8Zr liner, High burnup8 × 8		
Cooling time of fuel	7-9 years		
Status	Loaded	Empty and Reserve	Under manufacturing

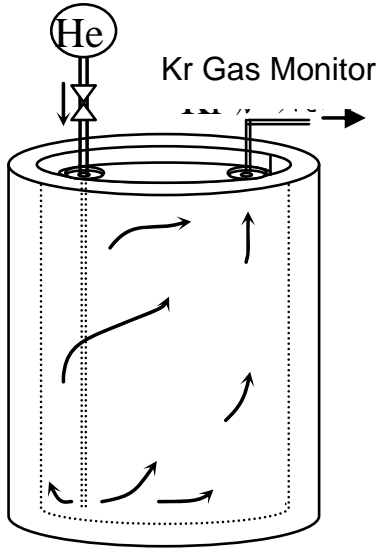
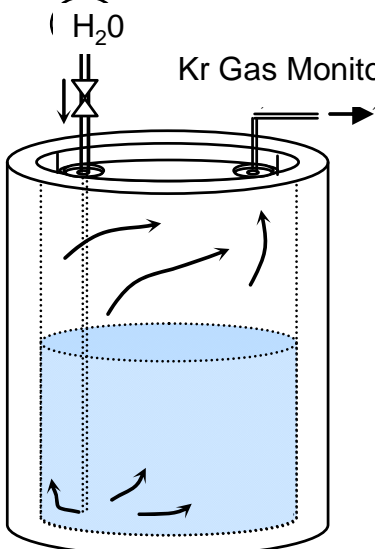
-cover gas sampling (to detect Kr-85) -

Stage	Substitution of cover gas	Feeding of water
image

Kr-85	Not detected	Not detected

The integrity of spent fuel cladding during the storage and while feeding water was confirmed.

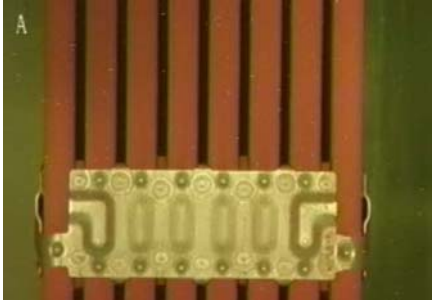
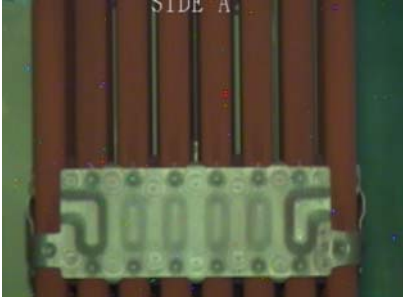
HTK016	
Before loading (October,2001)	At the inspection (January,2009)

- The appearance of spent fuel remains the same as observed at the storage started.
- The integrity of spent fuel appearance was confirmed.
