# Seismic Margin Evaluation of Civil-engineered Structures at Nuclear Power Plants

## Background and Objective

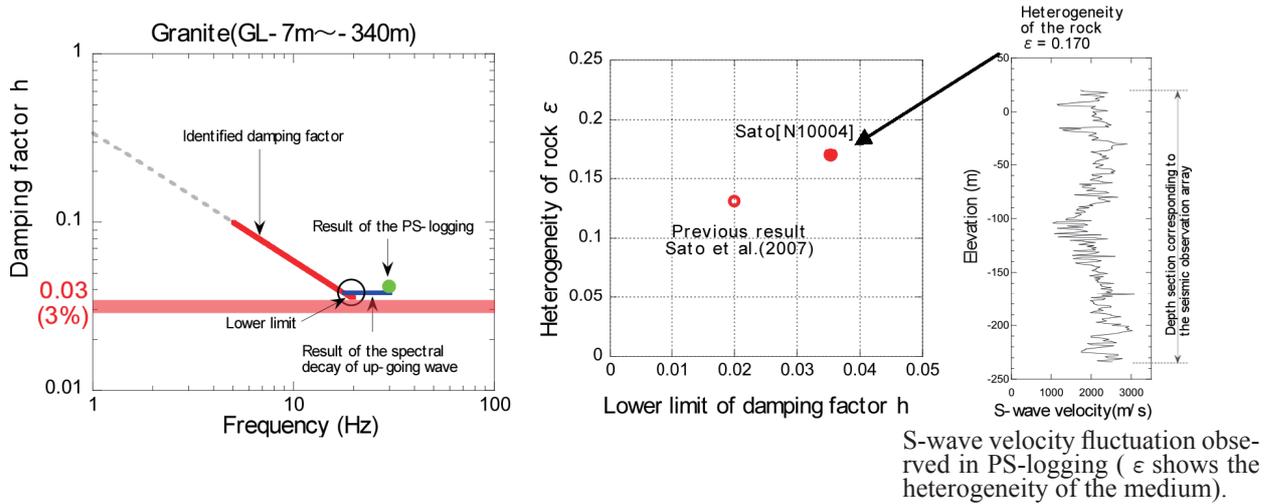
**Fig. 1 Damping factor of near surface rock**

Lower limit of the damping factor of the near surface rock identified from the seismic records is consistent with the damping factors derived from PS-logging and spectral analysis of up-going waves (left). The right figure shows the relationship between the lower limit of damping factor of rock and the S-wave velocity fluctuation.

We identified a damping factor of near surface rock from borehole earthquake records using the bi-linear-type frequency dependent damping factor model which has a frequency dependent lower limit. The identified lower limit of about 3% was in good agreement with the other estimations at the same borehole using PS-logging and spectral decay of up-going wave. We also showed the relationship between the identified lower limit of damping factor and the standard deviation of random S-wave velocity fluctuation of the rock observed in the PS-logging [N10004] (Fig.1).

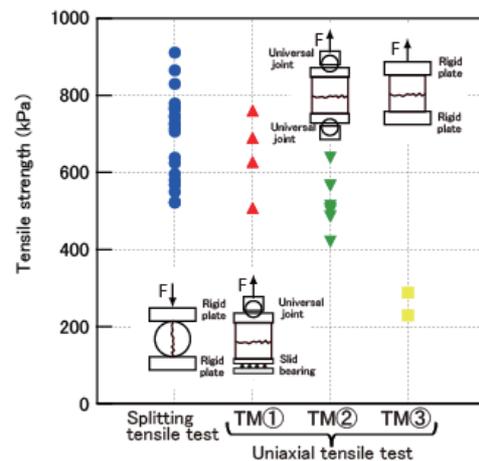
**Fig.3 Tensile strength evaluated by a splitting tensile test and uniaxial tensile tests**

The tensile strengths obtained by the conventional splitting tensile test and the uniaxial tensile test (TM①) installed a universal joint and a slide bearing at both ends are in reasonable agreement.

When a major earthquake occurs, the foundation ground under a reactor building and the surrounding slopes are subjected to tensile stress. The tensile stress has been estimated as zero for various reasons, for instance, it has not been possible to measure the reliable tensile strength of rock mass in the field. We conducted several types of tensile tests in the laboratory to evaluate the tensile strength of Tuff stone and compared the results to find a rational test method (Fig. 3).

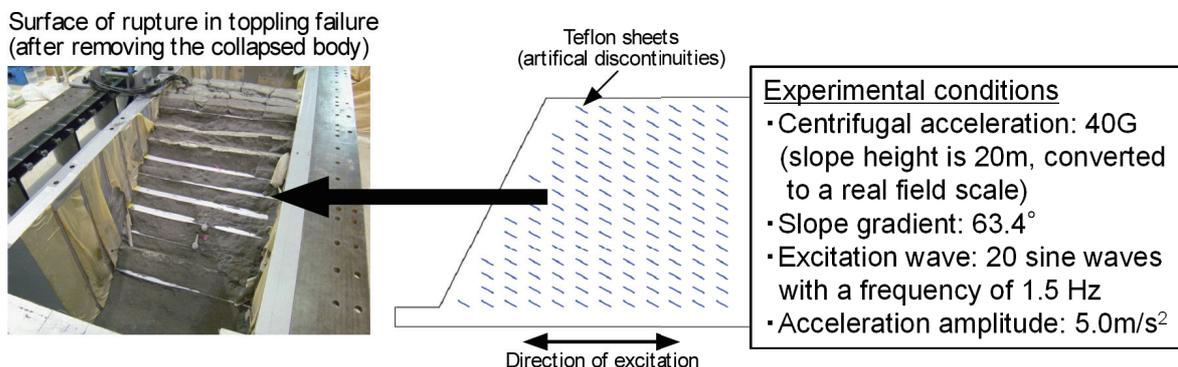
**Fig.4 Earthquake-induced rock slope failure by centrifuge model test**

We obtained experimental data on characteristic failure behavior of rock slope (ex. toppling failure, plane failure) by the centrifuge model test using the slope model with discontinuities imitated by Teflon sheets.

We conducted a centrifuge model test on earthquake-induced rock slope failure for the verification and improvement of the numerical methods that can evaluate the behavior of rock slopes around the facilities in nuclear power plants during major earthquakes. In the experiments, we found that the characteristics of the artificial discontinuities in the model considerably affected the collapse behavior of the slope (Fig.4).
